NIST NCSTAR 1-5A

Federal Building and Fire Safety Investigation of the World Trade Center Disaster

Visual Evidence, Damage Estimates, And Timeline Analysis

(Chapter 9 - Appendix C)

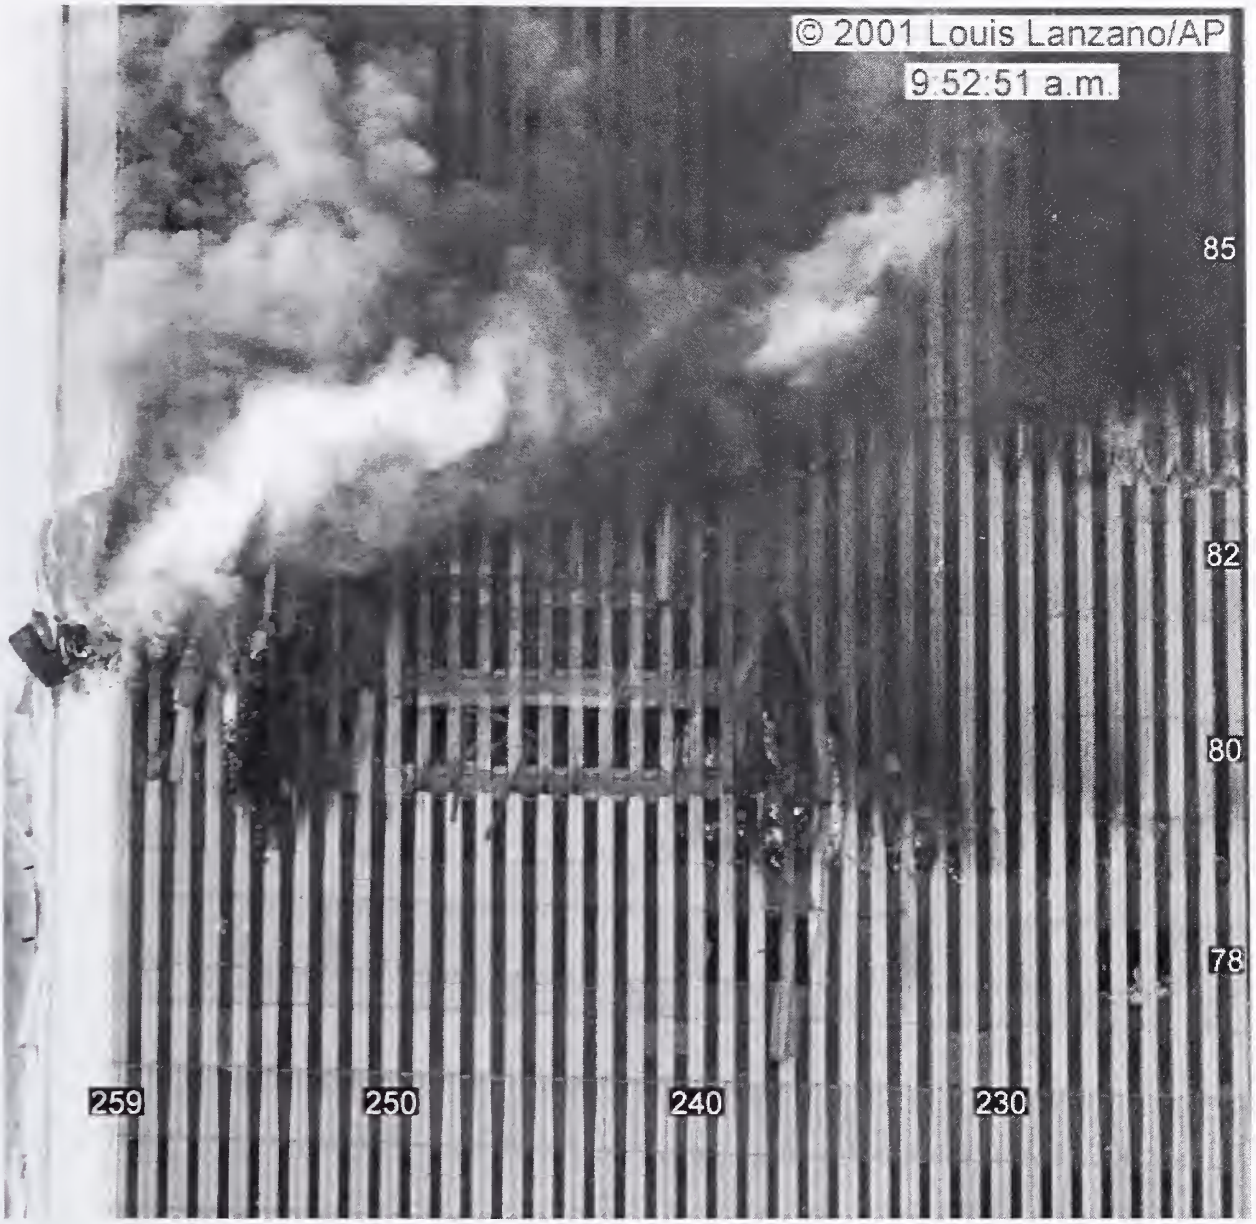
A high-resolution photograph of the north face shot at 9:52:51 a.m., i.e., just 4 s after the start of the first of the three pressure pulses, is shown in Figure 9–71. The white cloud in the photograph is the rising dust and/or smoke that was pushed from windows on multiple floors during the pressure pulse. Blow-ups of the area around window 80-255, which is the location on the 80th floor where the molten material poured from, and the cold spot are shown in Figure 9–72 and Figure 9–73, respectively.

Figure 9-71. This cropped photograph shows the north face of WTC 2 at 9:52:51 a.m. The image has been enhanced by adjusting the intensity levels, and column and floor numbers have been added. The arrows highlight a hanging object visible through open windows on the 80th floor.

As seen in Figure 9–71, the fire located on the 83rd floor in windows 83-221 to 83-225 continued to burn vigorously at 9:52:51 a.m. Recall that flames first appeared in this area at 9:42:53 a.m. Other images available around this time show no apparent additional spread of this fire towards the west. Carets are visible on many of the aluminum column covers between columns 83-222 and 83-236. Many of these carets are near the base of the windows, providing an indication for the intensity of the flames that were present at these locations earlier.

There appears to be a small fire burning on the 84th floor in window 84-223. This is an interesting observation because it is likely that this fire was ignited by flames coming from below, possibly through a window opened by the heat coming from the 83rd floor. If so, this would represent the clearest example of upward flame spread by an external pathway observed on September 11, 2001. On the 79th floor the fire burning on the debris pile is still visible in windows 79-232 to 79-239. The fire on this floor that had earlier spread to the west has died down and is no longer visible.

Smoke is visible coming from multiple windows near the western edge of the face on the 88th and 93rd floors. These windows have previously been identified as possibly having been broken open by people. Clearly, smoke is continuing to pass up through the core of the tower to these floors.

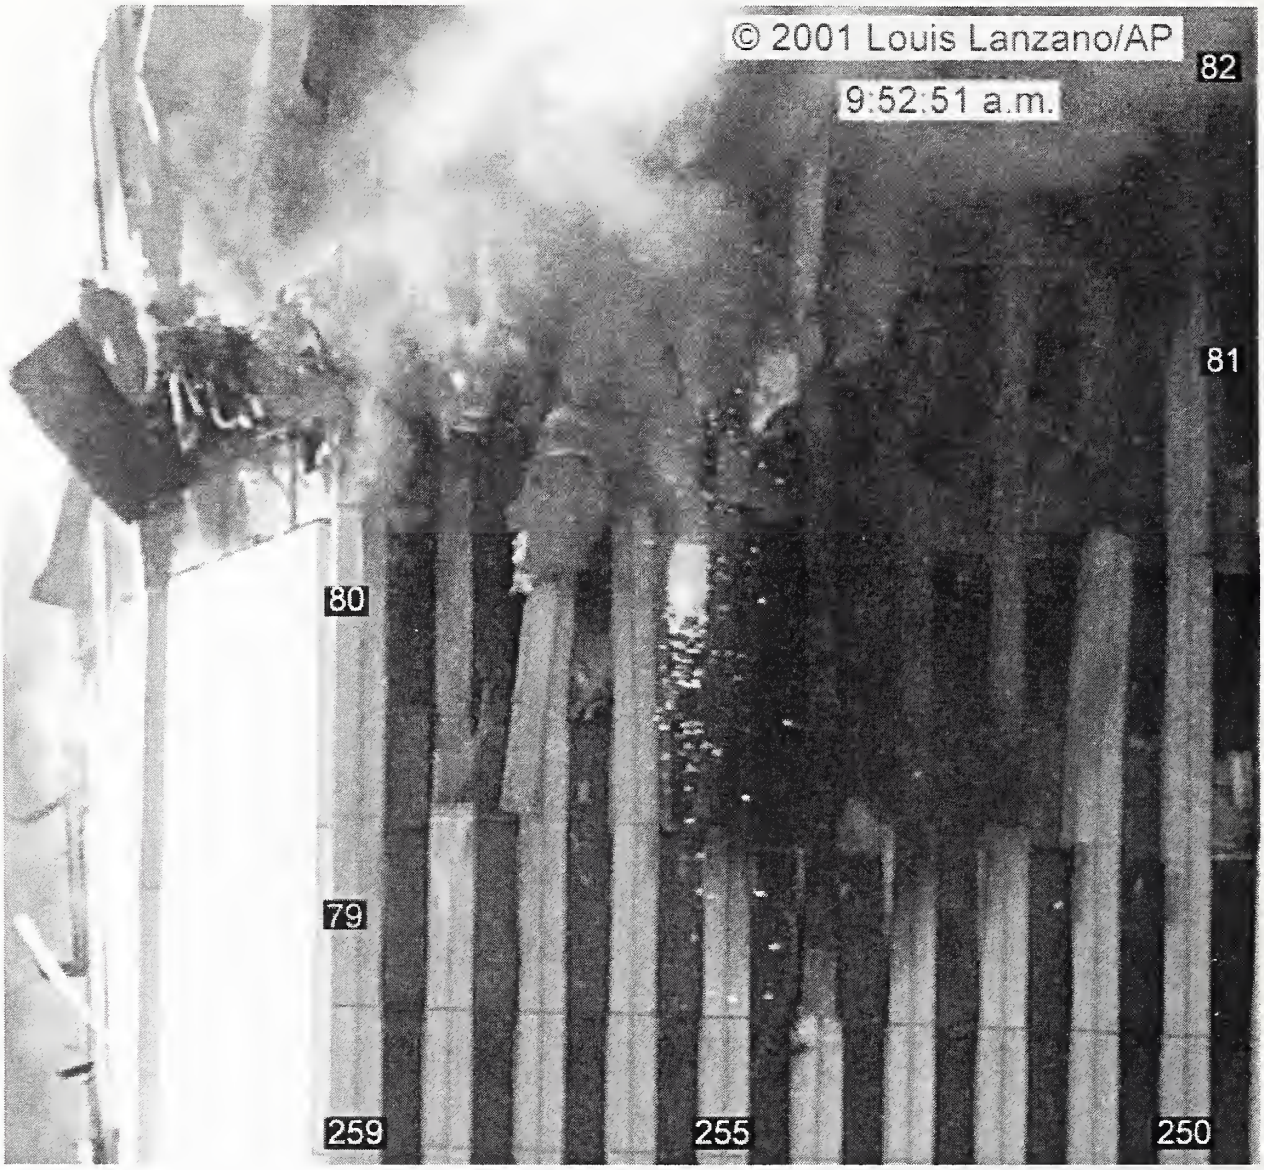
First, consider Figure 9–72. Videos show that a small amount of molten material poured from window 80-255 within a second or two after this photograph was taken. In the photograph the bright material is visible inside this window at the top. The area seems to be surrounded by a large number of glowing drops, which are likely associated with the liquid that will pour out shortly. Dull, deep-red glowing areas are just visible at the tops of windows 80-252 and 80-254. These might be an indication that the 81st floor slab has sunken below the spandrel at the base of this floor.

Figure 9-72. This image is a blow-up of a portion of Figure 9–71 showing the north face of WTC 2 around window 80-255 at 9:52:51 a.m. Column and floor numbers have been added.

This image provides a good view of the fire that continues to burn in the northeast corner on the 81st floor. It can be seen that column 81-254 on this floor is severely distorted. This damage may be a result of the landing gear that was identified as passing through the area during the aircraft impact (see the discussion in Section 7.4.3). Flames are also visible on the 79th floor through open windows 79-252 to 79-254. The orange color visible through the glass that remains in place in window 79-251 and windows 79-255 to 79-258 shows that fire is present behind these closed windows as well. This is one of a limited number of cases in which flames were seen through windows with glass still in place. In Figure 9–61, which was shot at 9:46:32 a.m., small flames could be seen in window 79-254. At this time the glass for window 79-252 was still intact.

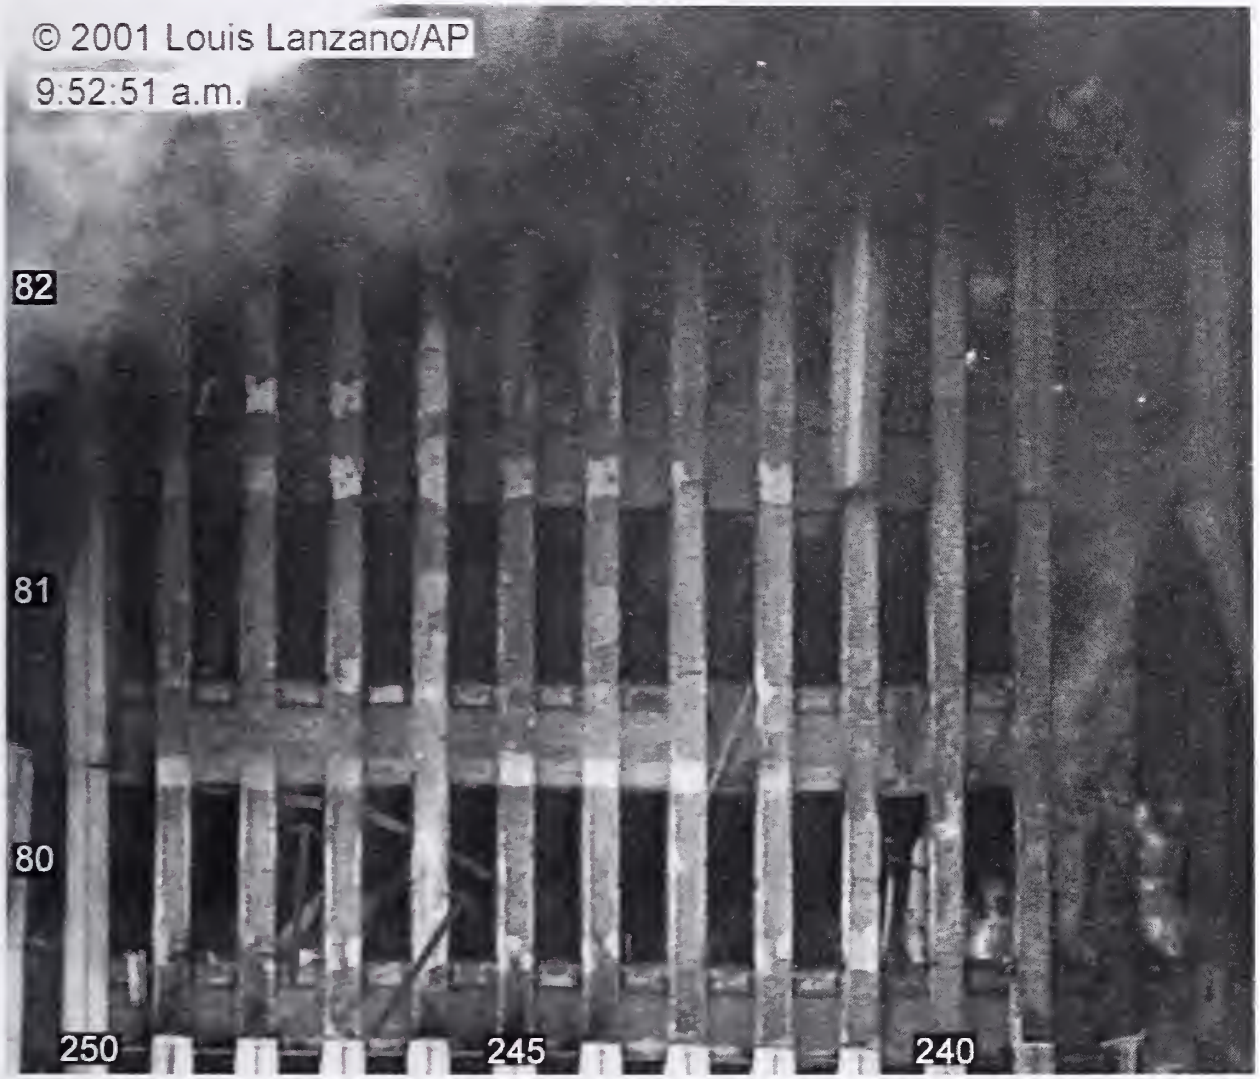
It is instructive to compare the image of the cold spot in Figure 9–73 with the close up shown in Figure 9–62, which was taken nearly 6 min and 20 s earlier. The first thing to note is that the hanging object on the 80th floor did not change position between 9:46:32 a.m. and 9:52:51 a.m. The fire burning on the west side of the cold spot on this floor has died down somewhat.

Figure 9-73. This image is a blowup of a portion of Figure 9–71 showing the cold spot on the north face of WTC 2 at 9:52:51 a.m. Column and floor numbers have been added. The arrows highlight a hanging object visible through open windows on the 80th floor.

The hanging object visible on the 81st floor at the earlier time is not apparent in Figure 9–73. This could simply be due to lighting, since the later photograph is somewhat darker, even though the intensities have been adjusted. In Figure 9–62 small flames were visible through window 81-243. In the later image these flames are not evident, but there is a curved region of dull red flames running from the top of window 81-242 to the middle of window 81-239. It is unclear why these flames are raised, i.e., what is holding them up in the window. One possibility is that the fuel for the fire is on top of a section of the 82nd floor slab (not visible) that became dislodged and settled below the spandrel at the base of the floor.

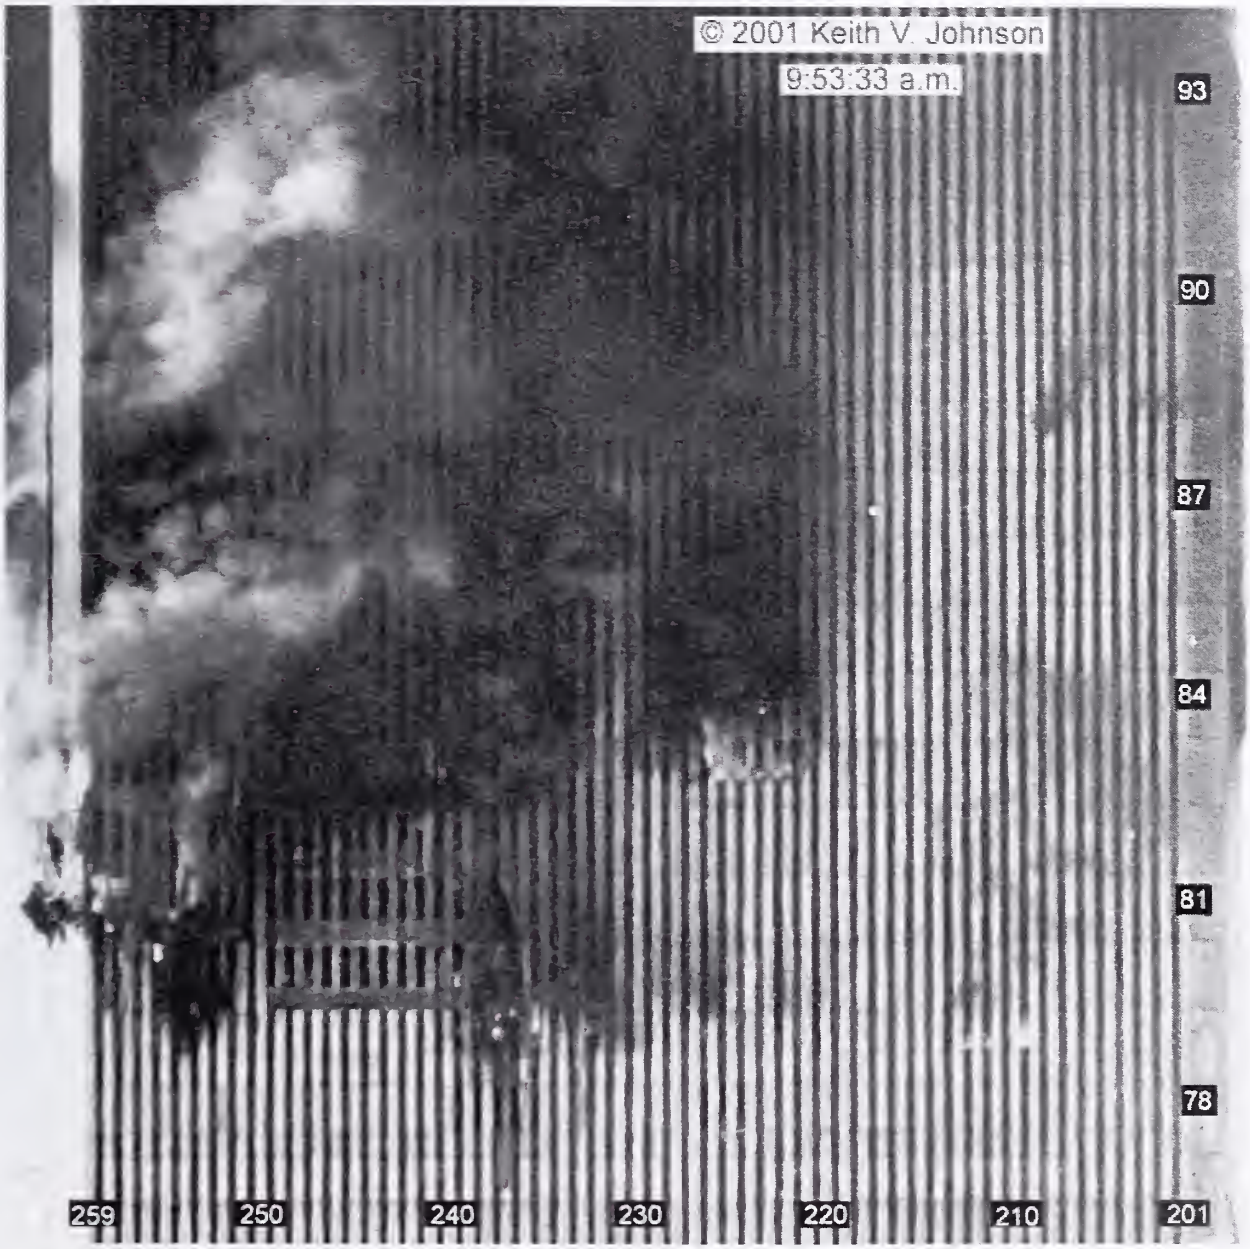
At 9:53:41 a.m. and 9:53:46 a.m. two pressure pulses forced additional smoke from windows on the north face. Both of these occurrences were accompanied by short flows of molten material from the same window, 80-255, on the 80th floor observed earlier. The largest flow occurred during the second release. Figure 9–75 shows a view of the northeast corner of WTC 2 taken from a video at 9:53:51 a.m. The bright molten stream flowing from the top of window 80-255 is prominent. Unlike earlier images (e.g., see Figure 9–71 and Figure 9–74, both of which were taken within a minute of 9:53:51 a.m.) showing this area of the tower, the intense fire burning on the 81st floor at the eastern edge of the north face has

substantially died down, and it is now possible to see clearly the 82nd and 83rd floors above for the first time. Videos suggest that the fire intensity at this location decreased around the time of the first pressure pulse at 9:53:41 a.m.

Figure 9-74. This cropped photograph shows the north face of WTC 2 at 9:53:33 a.m. The intensity range has been adjusted, and column and floor numbers have been added.

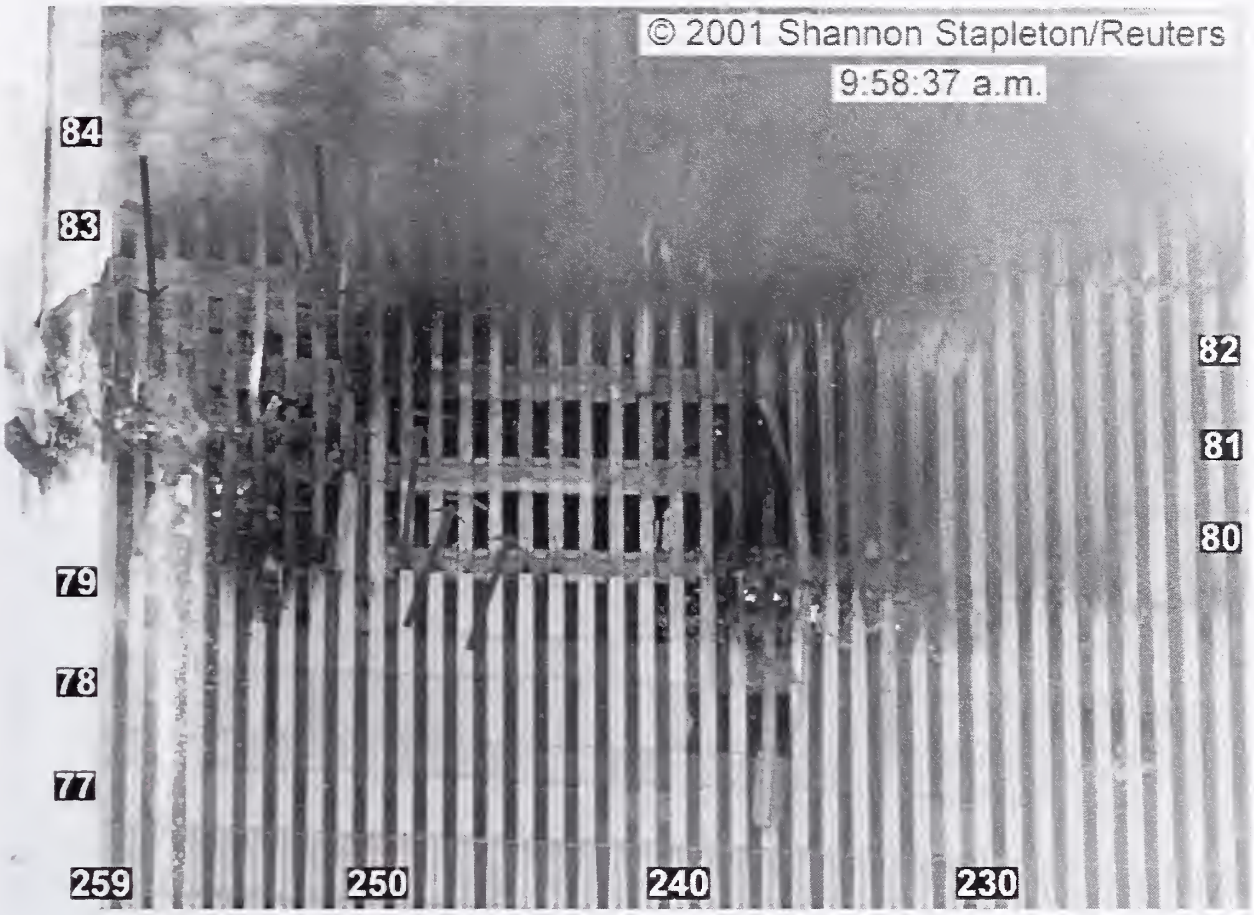
Figure 9–78 shows a photograph of the north face of WTC 2 taken at 9:58:37 a.m. The bright source of the recent molten metal flows stands out at the top of window 80-256 on the 80th floor. Some metal is visible flowing from the window at this time. An area, including this window and a portion of the cold spot, is blown up in Figure 9–79.

It is useful to compare Figure 9–78 with Figure 9–71, which was taken 5 min and 46 s earlier. Starting on the 83rd floor, it can be seen that the fire in windows 83-231 to 83-235 has died down considerably over the period between the photographs. In both cases the most intense flames are in window 83-225. Photographs and videos taken just prior to the collapse provide no indication of westward fire spread on this floor beyond window 83-220. The fire in this area grew rapidly just after 9:45 a.m. Apparently, it did not spread further after this time. The carets visible at the top of the adjacent columns show how intense the burning was in the area. The incipient fire on the floor above in window 84-223 is barely visible.

Figure 9-78. This cropped photograph shows the north face of WTC 2 at 9:58:37 a.m. The intensity levels have been adjusted, and column and floor numbers have been added. Arrows highlight hanging objects visible through open windows on the 79th, 80th, 81st, and 82nd floors.

The fire on the 82nd floor to the west of the cold spot, which grew rapidly just before 9:54 a.m., has continued to spread and grow. In Figure 9–71 there was no indication of this fire. At 9:58:37 a.m. flames are coming from windows 82-230 to 82-232. There are carets on the aluminum column covers around these windows, as well as on the covers next to windows 82-233 to 82-236. This fire seems to not only be spreading rapidly, but also to be going through a rapid cycle of growth and decline. Windows to the west of window 82-230 appear to have intact glass. No flames are visible in or to the east of the cold spot on this floor. At the earlier time the area was hidden by smoke.

During the period between when Figure 9–71 and Figure 9–78 were taken, the fires on the eastern edge and the northeast corner of the 81st floor have died down considerably. Prior to 9:53 a.m. intense fires had burned in these areas continuously following the aircraft impact. After this time it was observed that these fires suddenly died down and then reappeared several times. These cycles seemed to be associated with pressure pulses that pushed smoke and/or dust out of open windows on multiple floors of the north and east faces. This may be an indication that these fires died down due to changes in their local environment, e.g., a partial collapse of a floor, as opposed to simply burning out the available fuel. A low-level fire continued to burn at the western edge of the cold spot on the 81st floor. There had been no

The fires burning on the 79th and 80th floors between columns 230 and 241 have also died down. As a result, the large amount of debris piled up in windows 79-234 to 79-240 is more apparent than in earlier images. It is still not possible to identify whether the fires on these two floors were burning on a single pile of debris, i.e., the intervening floor had collapsed, or as two independent fires.

The only indication in Figure 9–78 of a fire burning on the 79th floor to the immediate west of window 79-229 is a small flame visible through a partially broken window 79-224. The fires that had been burning in this area earlier have nearly died out. Windows 79-221 and 79-223 to 79-225 still have glass. Half of the window pane is in place in window 79-222. These observations suggest that the fire that burned in this area was not too intense. Videos show that the fire that grew further west in windows 79-109 to 79-113 (see Figure 9–76) continued to burn at a comparable intensity until the tower collapsed. In Figure 9–78 it can be seen that window glass remains in place on the 80th floor in window 80-231 and windows to the west. Videos show occasional smoke coming from window 80-204 starting after 9:55 a.m. There is no indication of fire at this location. This window may have been broken earlier by a person.

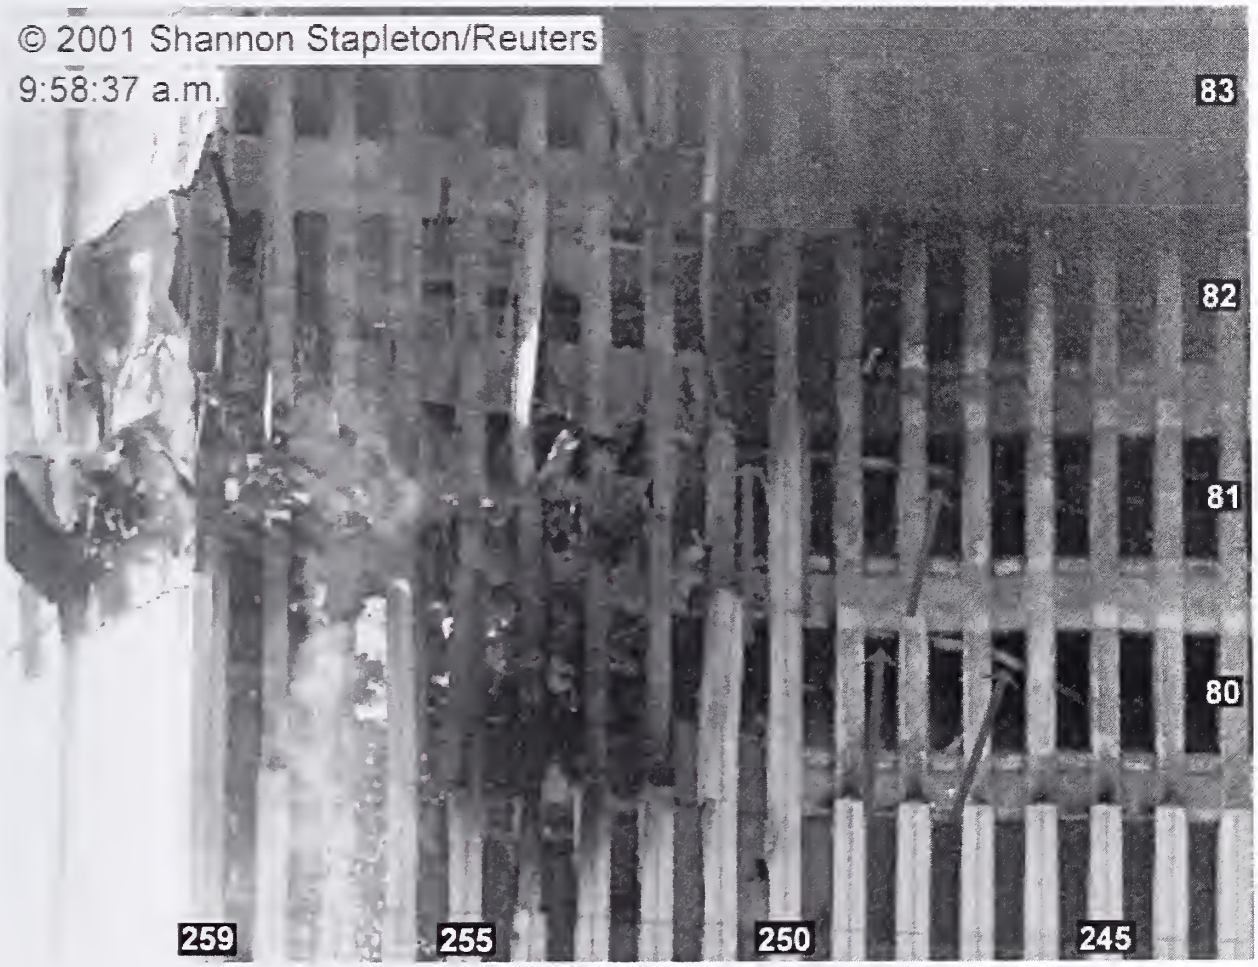
The blow-up of a section of Figure 9–78 shown in Figure 9–79 provides a closer view of the area around the 80th-floor window 80-256 and a portion of the cold spot. Since smoke is no longer obscuring the east side of the 81st floor, it is possible to see additional details concerning the damage in this area. The distortion of column 254 on the 81st floor, which was described earlier, is apparent. The column just to the west, 253, has been cut through near the top of the window. The spandrel at the base of the 82nd floor between column 251 and column 252 appears to be torn. It is not possible to say with certainty, but it is likely that this steel damage resulted from the large object observed exiting near this location during the aircraft impact (see the discussion in Section 7.4.3) and that it is not due to subsequent events.

On the 81st floor a hanging object is apparent in Figure 9–79 at the tops of windows 81-247 to 81-250. A faint trace of the object in the two windows to the west indicates the object is sloping sharply downward in windows 81-246 and 81-245. This object was not visible in the close-up of the area shown in

Figure 9–73, which was taken at 9:52:51 a.m. This was true even when the intensity levels for the photograph in Figure 9–73 were adjusted to emphasize the darkest levels. Interestingly, a hanging object is visible in this same vicinity in Figure 9–62, which was taken at 9:46:32 a.m., but it was located further west and had a different shape. A detailed comparison shows that the objects in the two photographs are at roughly the same height in window 81-250, but while the object curved upwards in windows 81-249 and 81-248 and disappeared above the spandrel in window 81-247 in Figure 9–62, in the later image it slopes downward in windows 81-249 to 81-247. At the earlier time the object reappeared in window 81-245 and then sloped gradually downward toward the west. In Figure 9–79 the object nearly disappears in window 81-246 and seems to be curving strongly downward to the west.

Figure 9-79. This photograph is a blow-up of a portion of the photograph shown in Figure 9–78. It shows the north face of WTC 2 and includes window 80-256 and part of the cold spot. The intensity levels of the original have been adjusted, and column and floor numbers have been added. Arrows highlight hanging objects visible through open windows on the 79th, 80th, 81st, and 82nd floors.

It is difficult to understand why the object is not visible in Figure 9–73 at 9:52:51 a.m. Either it is hidden by some unanticipated optical effect or the object moved between 9:46:32 a.m. and 9:52:51 a.m. If the former is the case, it means that the object visible at 9:46:32 was obscured sometime between 9:46:32 a.m. and 9:58:37 a.m. On the other hand, if the latter is the case, it suggests that the object visible at 9:46:32 a.m. sank down out of sight between 9:46:32 a.m. and 9:52:51 a.m. and that a second object

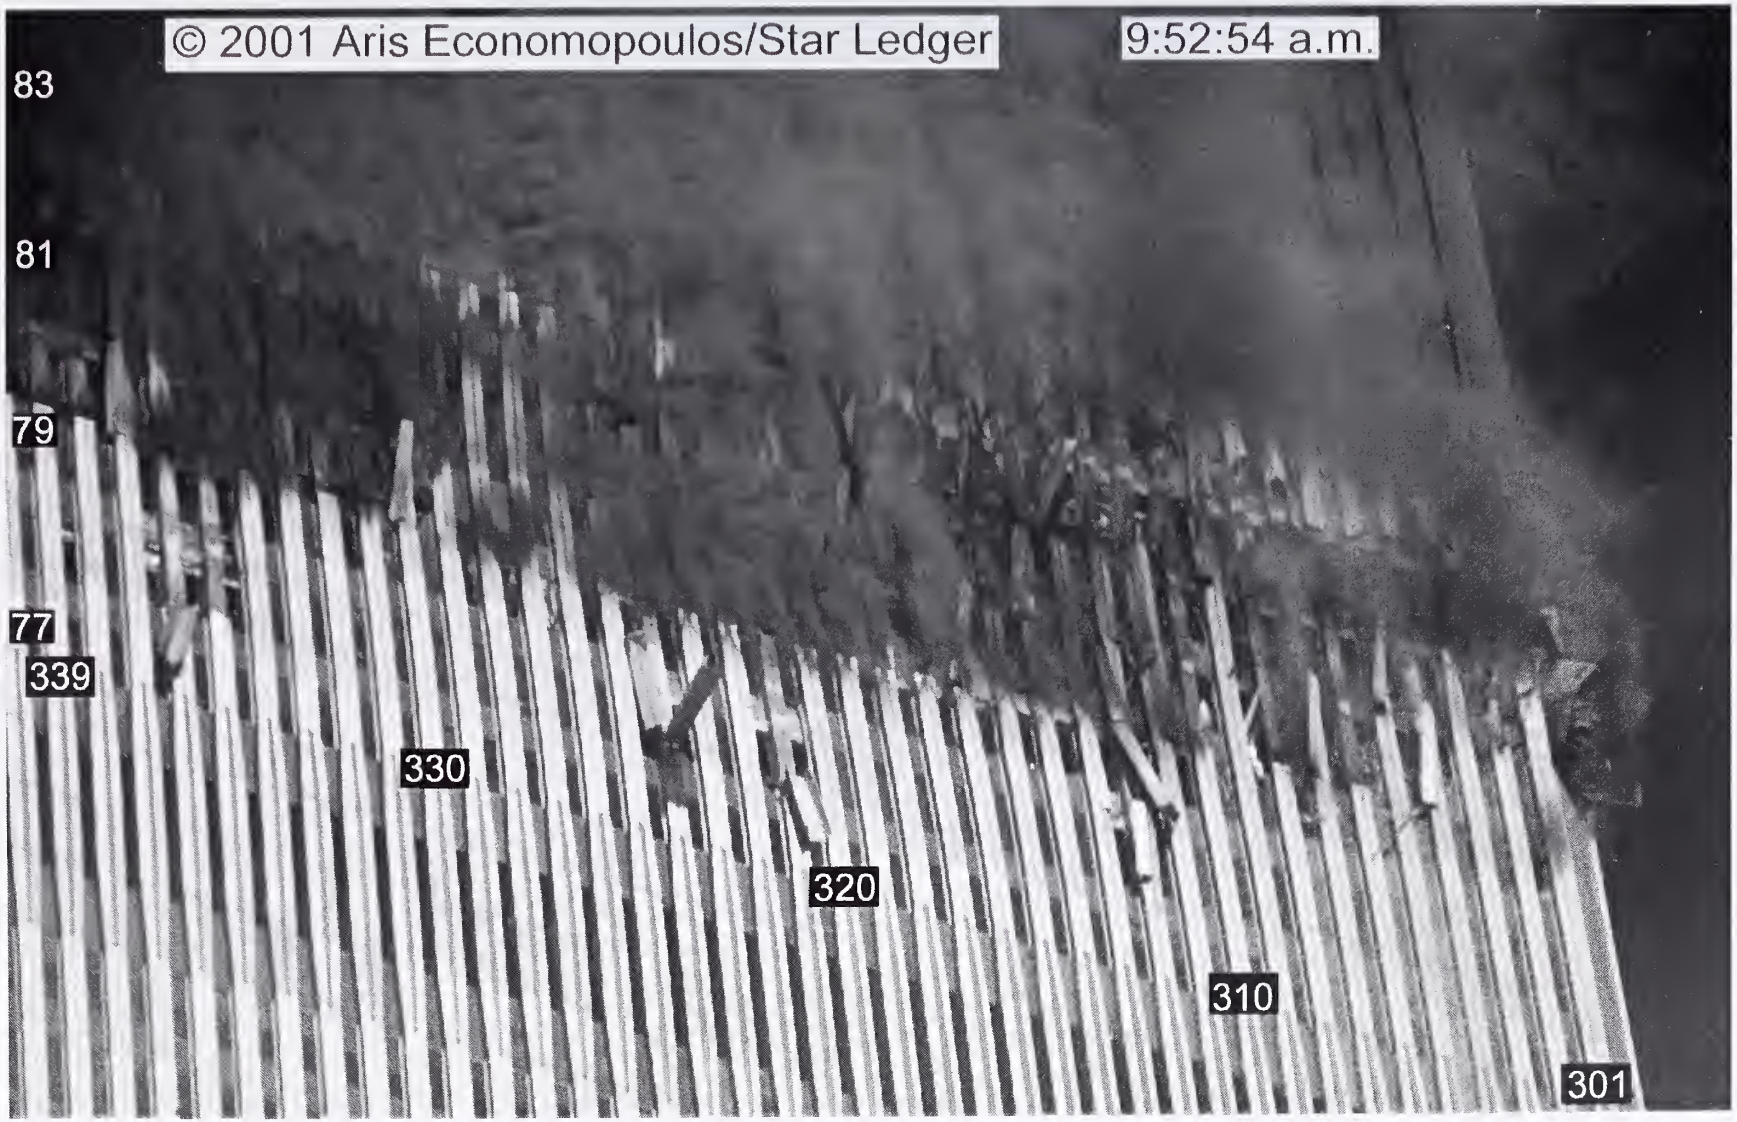
In Figure 9–67 heavy smoke was flowing from windows 79-314 to 79-320 on the 79th floor, and flames were extended from a number of these windows. In Figure 9–80 relatively light smoke is coming from windows 79-319 to 79-321, and there is no indication of external flaming. Apparently, the fires present in this area roughly 5½ min earlier have died down considerably. Carets at the tops of the covers for columns 79-312 to 79-324 indicate the relative local intensities of the fire that burned in this area earlier. In the photograph taken at 9:47:10 a.m. (Figure 9–67) the most intense burning at the northern edge of the 82nd floor was in windows 82-306 and 82-307. At the later time flames are only visible in window 82-303. On the other hand, the flames on the northern edge of the 81st floor are clearly more intense at the later time. Overall, the number and intensities of the fires on the east face appear to be at their lowest levels since the aircraft impact 50 min earlier.

Figure 9-80. This cropped photograph shows a view of the east face of WTC 2 at 9:52:54 a.m. The intensity levels have been adjusted, and column and floor numbers have been added.

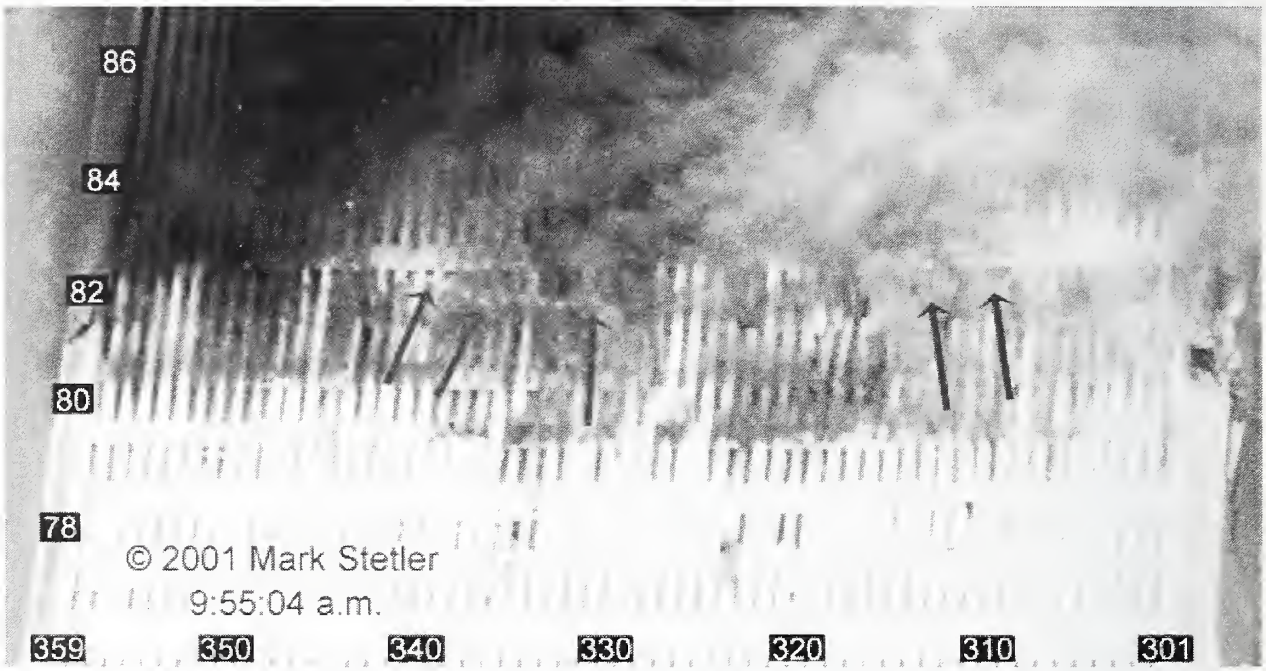
Figure 9–81 is a photograph of the east face that was taken at 9:55:04 a.m. This image was shot from a longer distance and from a higher position than Figure 9–80. In this image it is apparent that flames are present inside windows on the 79th floor over a length running from window 79-311 to window 79-319. This is roughly the same location as seen in Figure 9–67 at 9:47:10 a.m. Consistent with Figure 9–80, there is little smoke and no flame coming from the windows where fire is visible in Figure 9–81.

Figure 9-81. This cropped photograph of the east face of WTC 2 was shot at 9:55:04 a.m. The image has been rotated, and the intensities have been adjusted. Column and floor numbers have been added. Arrows indicate a hanging object visible through open windows on the 82nd floor.

There is also an area of flame visible on the 80th floor in Figure 9–81 extending from window 80-316 to window 80-326. Windows to the north of this length are hidden by smoke, while windows 80-327 and 80-328 on the other end still have glass in place. It is difficult to identify when this fire developed. These windows are visible in the east face view shown in Figure 9–48, which was taken at 9:38:22 a.m. At this time there was no indication of a significant fire in this area of the 80th floor, even though the fire on the 79th floor was already well developed. In similar views of the face shown in Figure 9–58 (9:40:29 a.m.), Figure 9–66 (9:45:40 a.m.), and Figure 9–67 (9:47:10 a.m.), smoke from the 79th floor hides these windows. Since the flames appear to be well inside and there is no smoke coming from the windows, it is not surprising that this fire can not be seen in Figure 9–80.

The arrows in Figure 9–81 highlight the hanging object visible through open windows on the 82nd floor. This object has been observed in a number of images, including Figure 9–67 at 9:47:10 a.m. On the southern end around window 82-340 the apparent position of the object has not changed during the almost seven minutes between the times when these photographs were taken. This is not the case at the northern end. At the earlier time the object was visible near the tops of windows 82-310 and 82-311. At 9:55:04 a.m. the object is visible at the top of window 82-309 and can be seen sloping downward across several open windows toward the left, approaching the base of window 82-315. This is another example of hanging objects, which may be dislocated floor slabs, changing position during the event.

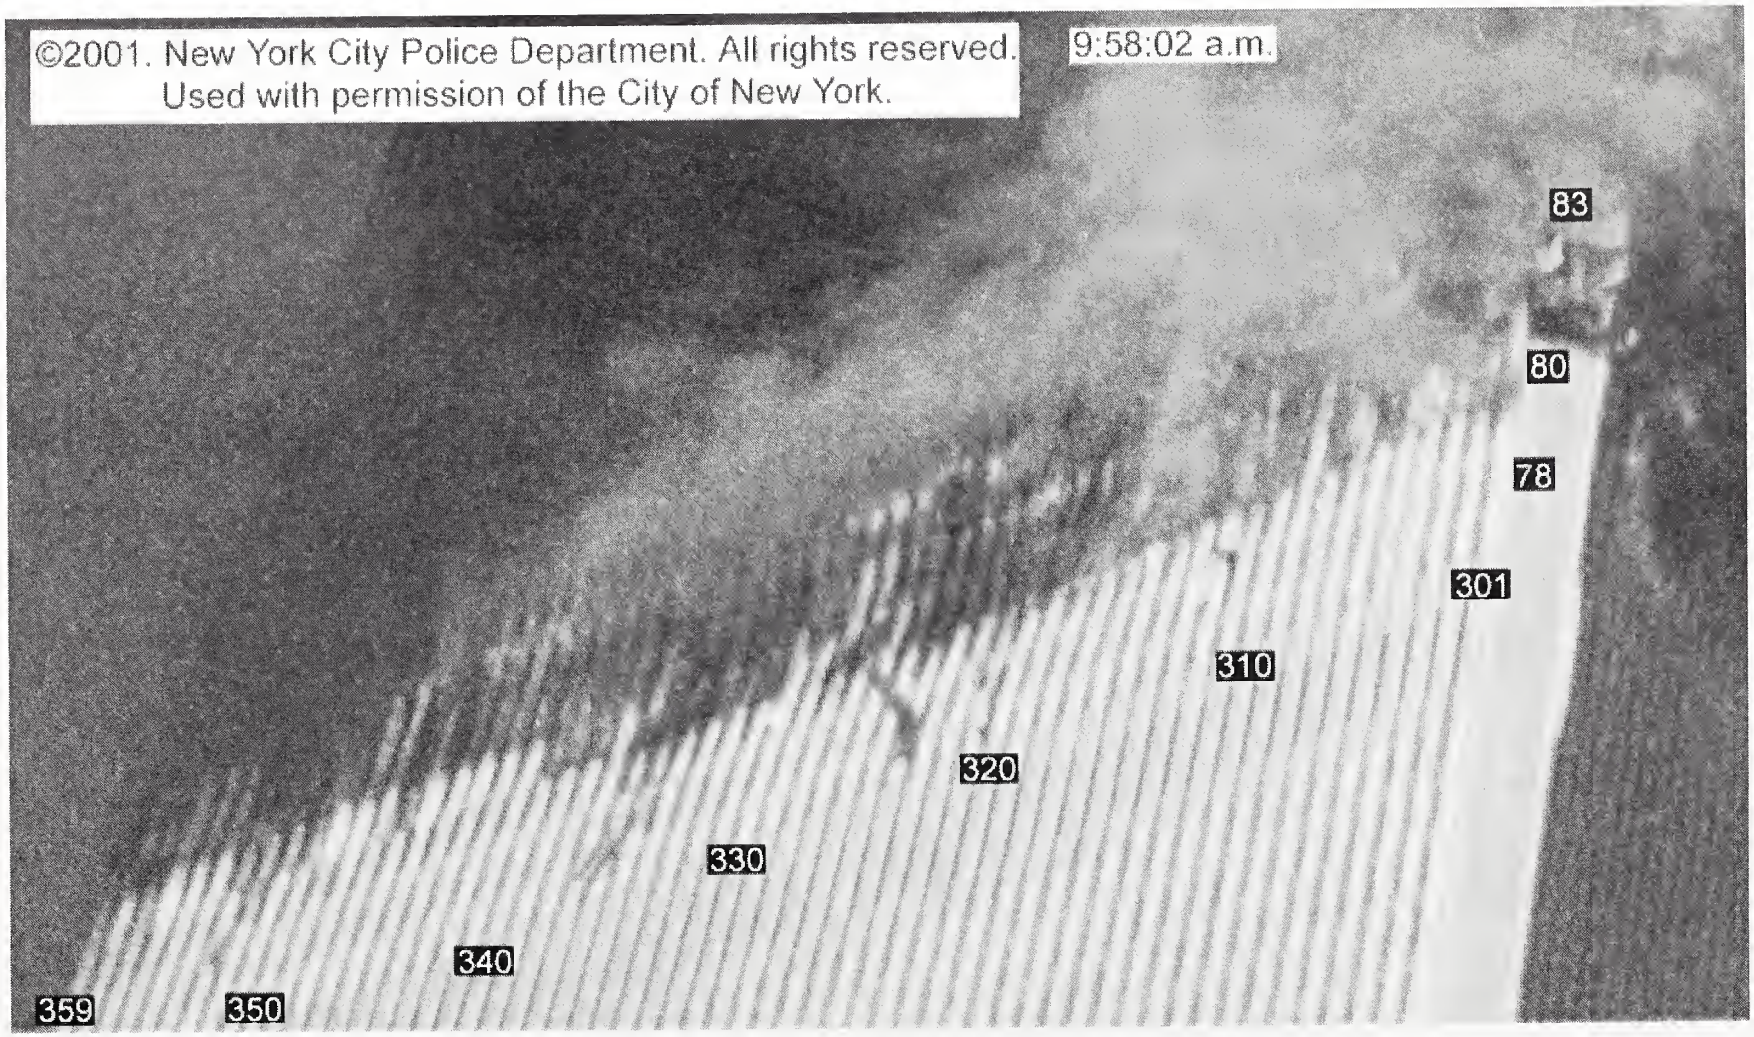
An even larger number of pieces of debris started falling from the same area around 9:58:49 a.m. This shower of debris lasted until the tower collapsed 10 s later. Figure 9–83 shows a photograph taken at 9:58:56 a.m., i.e., 3 s prior to the start of the collapse of WTC 2, from roughly the same location as Figure 9–82. A number of pieces of falling debris are visible on the north side of the east face.

The bowing of the columns near the center of the face stands out in Figure 9–83. Quantitative comparisons are difficult, but the bowing appears greater than in Figure 9–82. The fire visible at the northeast corner has a similar appearance to that seen earlier.

Figure 9-82. This cropped image shows the east face of WTC 2 at 9:58:02 a.m. The intensity levels have been adjusted, and column and floor numbers have been added.

Figure 9-83. This cropped image shows the east face of WTC 2 at 9:58:56 a.m. The intensity levels have been adjusted, and column and floor numbers have been added.

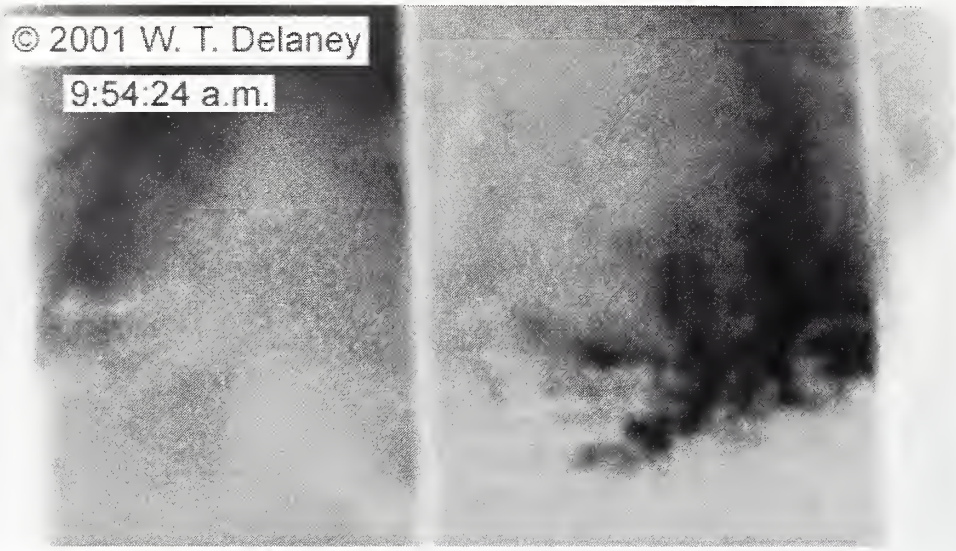
The video shot from the news helicopter shows that over the next few minutes the line of fire on the 80th floor had a steady appearance similar to that in Figure 9–85. Smoke flow from the fire area was generally light, even though there were occasionally streams of smoke released from various windows along the observed fire length. This situation changed at 9:56:44 a.m., when a heavy release of smoke lasting over 20 s took place from windows along the entire length of the fire. At this time the smoke appeared to be coming from as far west as window 80-454. Within 5 s of the start of the heavy smoke flow, large flames erupted from several windows centered near window 80-442. There was also a short flame flare from near window 80-450.

Figure 9-85. This cropped image shows the south faces of WTC 1 and WTC 2 at 9:54:24 a.m. The intensity levels have been adjusted.

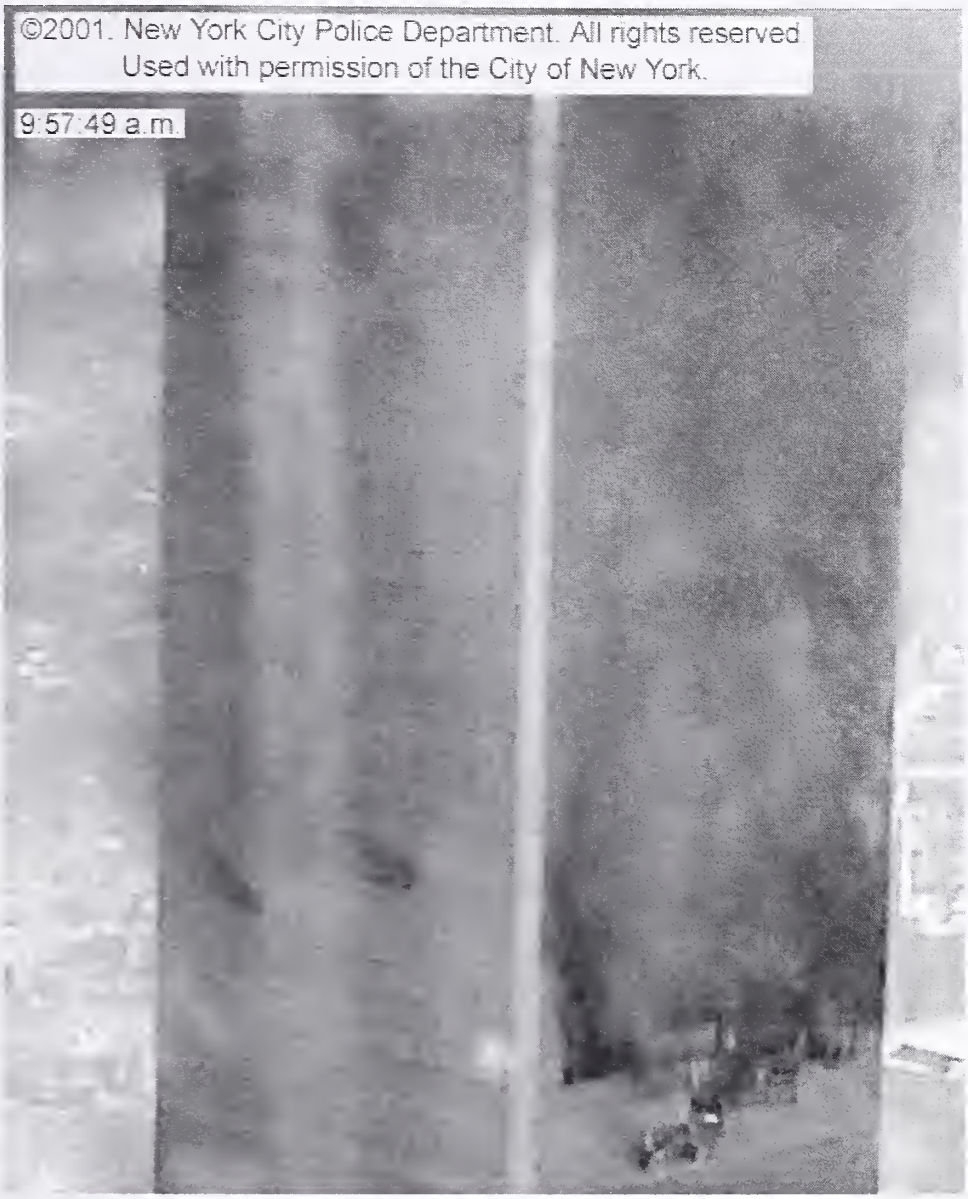
By 9:57:49 a.m. the smoke and flames on the 80th floor of the south face had subsided somewhat. The view of the south and west faces of WTC 2 at 9:57:49 a.m. shown in Figure 9–86 was taken from a NYPD helicopter looking down on the tower from the southwest. The line of smoke and flame to the west of the aircraft impact cavity on the south face is visible extending nearly to the west edge. Heavy smoke also appears to be coming from the 81st floor. There is a bright flame region visible near the 79th floor inside the aircraft impact cavity. Flames were observed in this general vicinity in several ground-based images including those in Figure 9–26 (9:23:08 a.m.) and Figure 9–41 (9:30:19 a.m.), even though such a large fire was not evident.

Views of the west face of WTC 2 at 9:52:27 a.m. and 9:57:49 a.m. are provided in Figure 9–84 and Figure 9–86, respectively. Smoke is coming from many of the open windows previously identified earlier as possibly having been broken by people. There are no indications of additional windows having opened, and no flames are visible. The visual evidence indicates that fires capable of breaking out window glass had not reached the west face of WTC 2 prior to the collapse.

Figure 9-86. This cropped photograph showing the west and south faces of WTC 2 was shot from a helicopter at 9:57:49 a.m. The intensity levels have been adjusted.

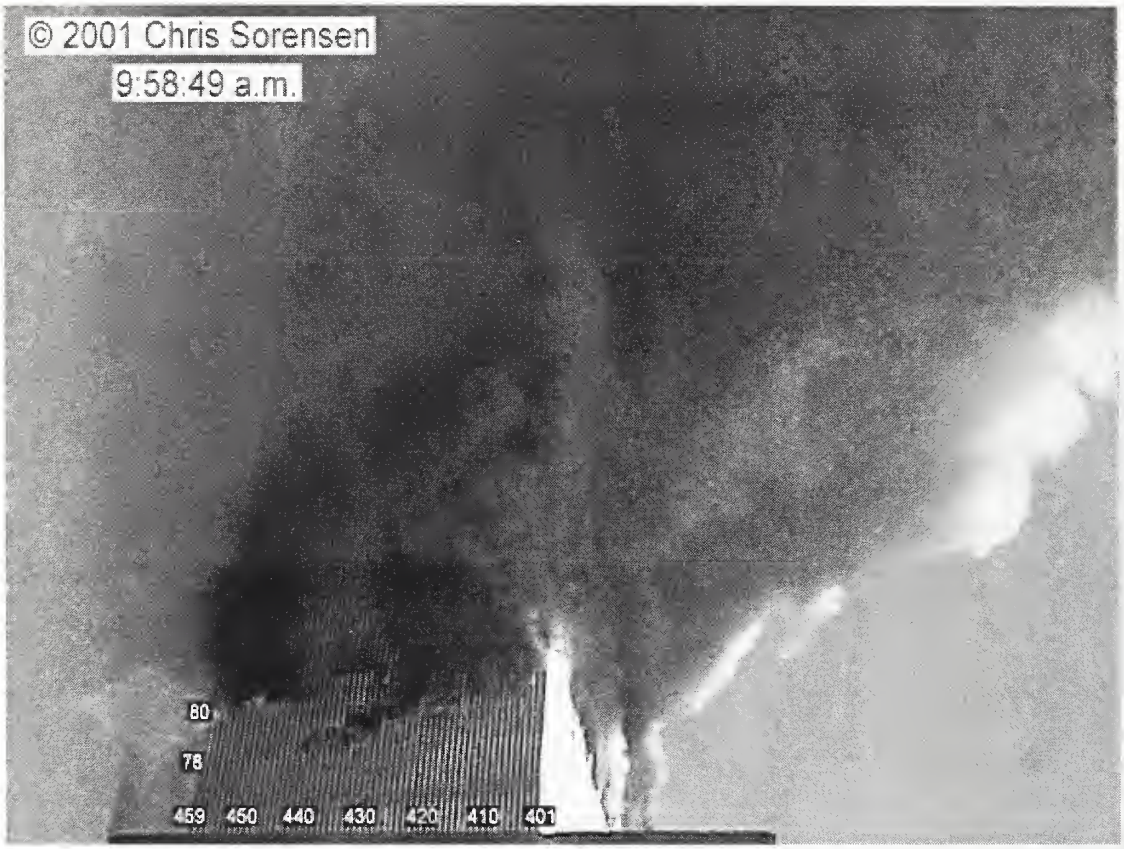
A view of the south face of WTC 2 captured from a video at 9:58:49 a.m. is shown in Figure 9–87. It was taken just 10 s before the start of the collapse of the tower. Flames are visible on the 80th floor from windows 80-440 to 80-452, and smoke is flowing from open windows 80-438 to 80-455. The aerial video shows that the bright region of flame near window 80-450 flared up briefly for several seconds around this time. There are no distinct flames visible at other locations on the face. In particular, the flames visible inside the aircraft impact cavity in Figure 9–86 are not seen from this angle.

Figure 9-87. This image of the south face of WTC 2 is a frame captured from a video recorded at 9:58:49 a.m. The intensity levels have been adjusted, and column and floor numbers have been added.
